# **Facilities Management 2014 Safety Committee Annual Report**

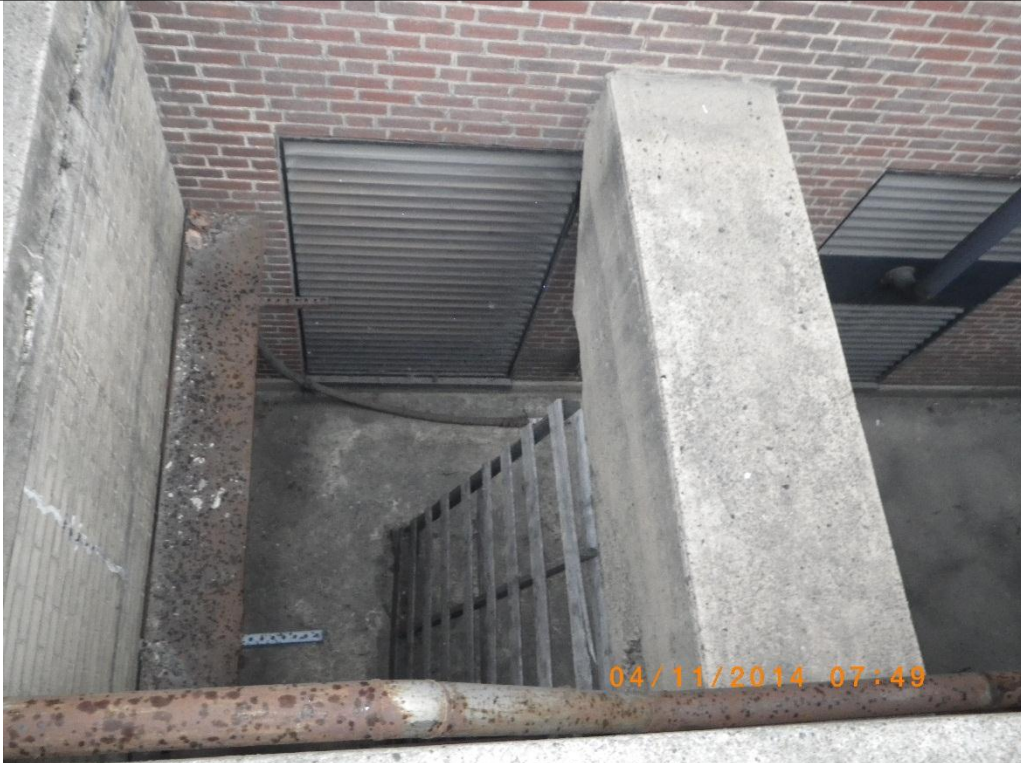
## Clark Hall ventilation pit

A wooden pallet was used to access the lower area to remove debris and other materials. The pallet is not an approved ladder and the drop distance was approximate 10 feet plus after climbing over the hand rail.

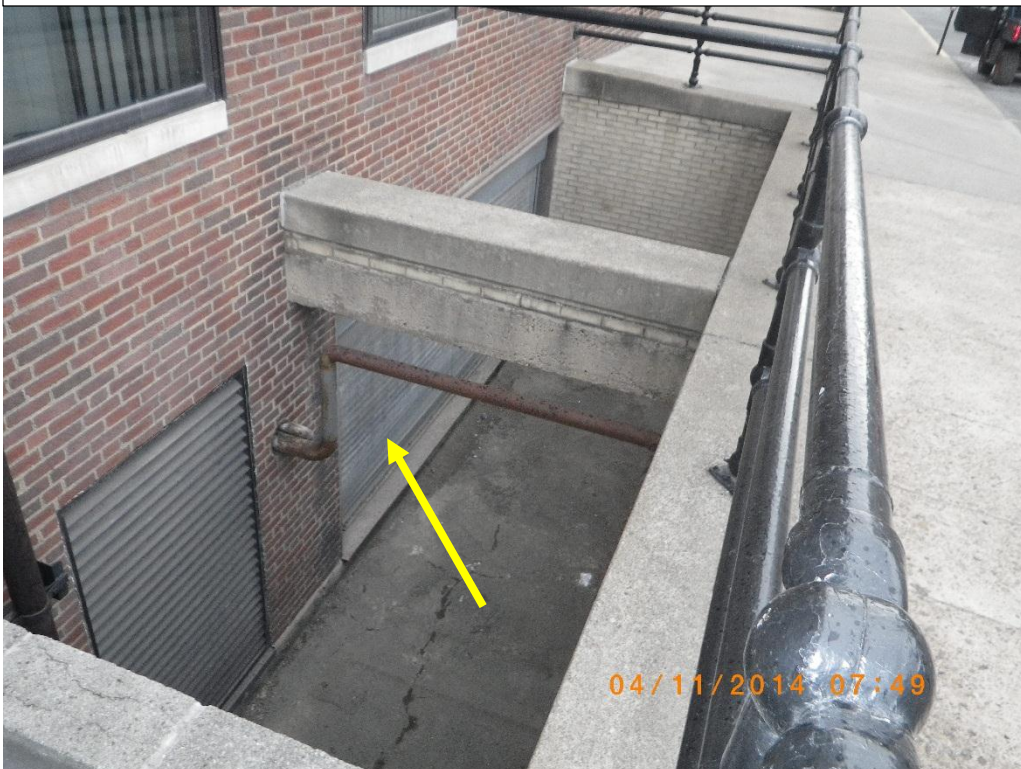
The pit was divided into two areas, separated by a concrete block wall. The one area of the pit could be accessed from within the building using a roll up garage door for entry (yellow).

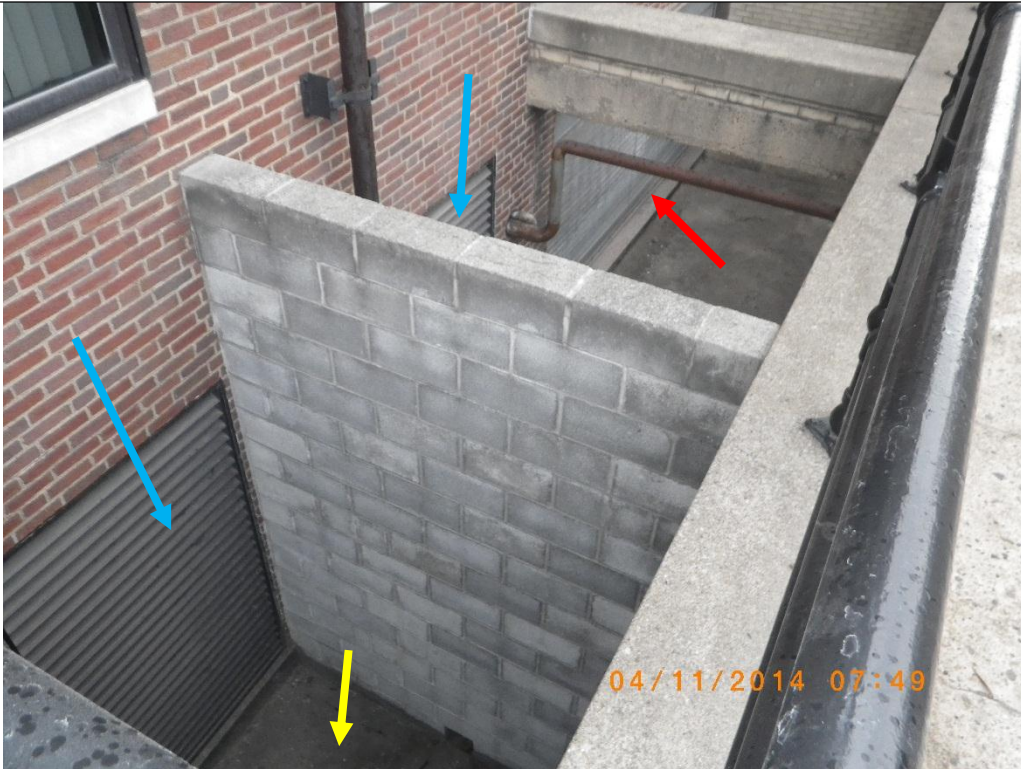
## Clark Hall ventilation pit

Concrete block wall which separates the pit into two areas. The block wall is necessary and designed to baffle the pit for adjacent air handling unit intakes (blue). Area one is located upper right (red) with access from the roll up door. Area two is located lower left (yellow) and accessed by pallet.

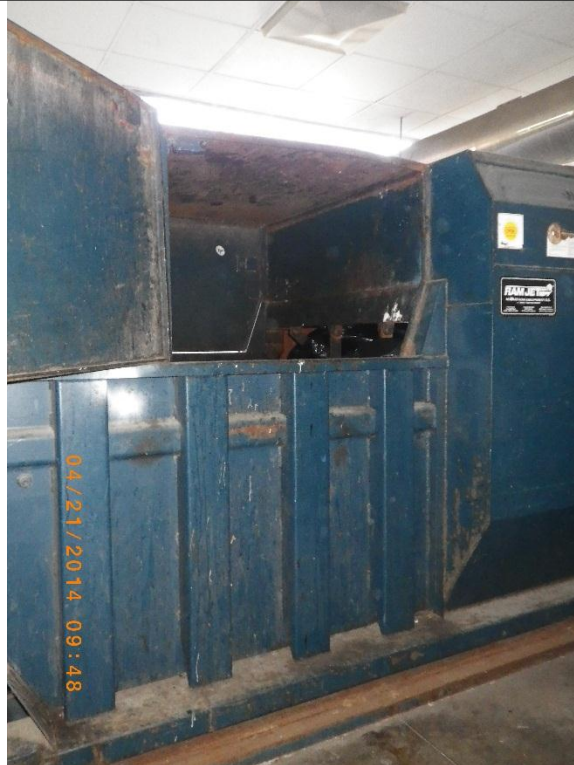
## One Water Front loading dock trash compactor

Trash compactor located on loading dock. Trash bags need to be lifted above recommended safe height and placed into the compactor. This would be very hard for employees that are not very tall or strong.

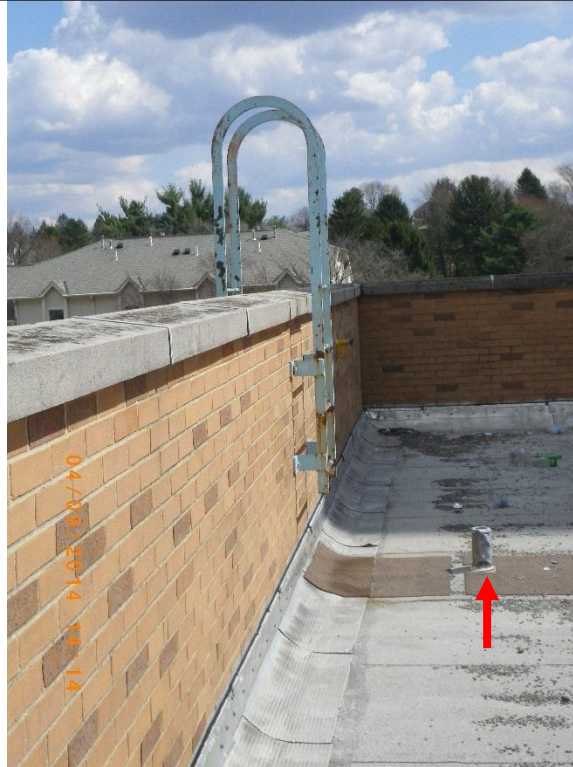
## Towers roof ladder and vent pipe

Access ladder on towers roof from upper roof to lower roof located over the ERC café. A vent pipe (red) was located near the bottom of the ladder is posed a potential trip hazard when exiting the ladder.

View from upper roof looking towards the ladder. Vent pipe (red) appears far from this angle, but as photted above is close to the exiting motion from the ladder. Solution was to move the ladder approximately 10' left (yellow) and reinstalled, where no hazards where presents.

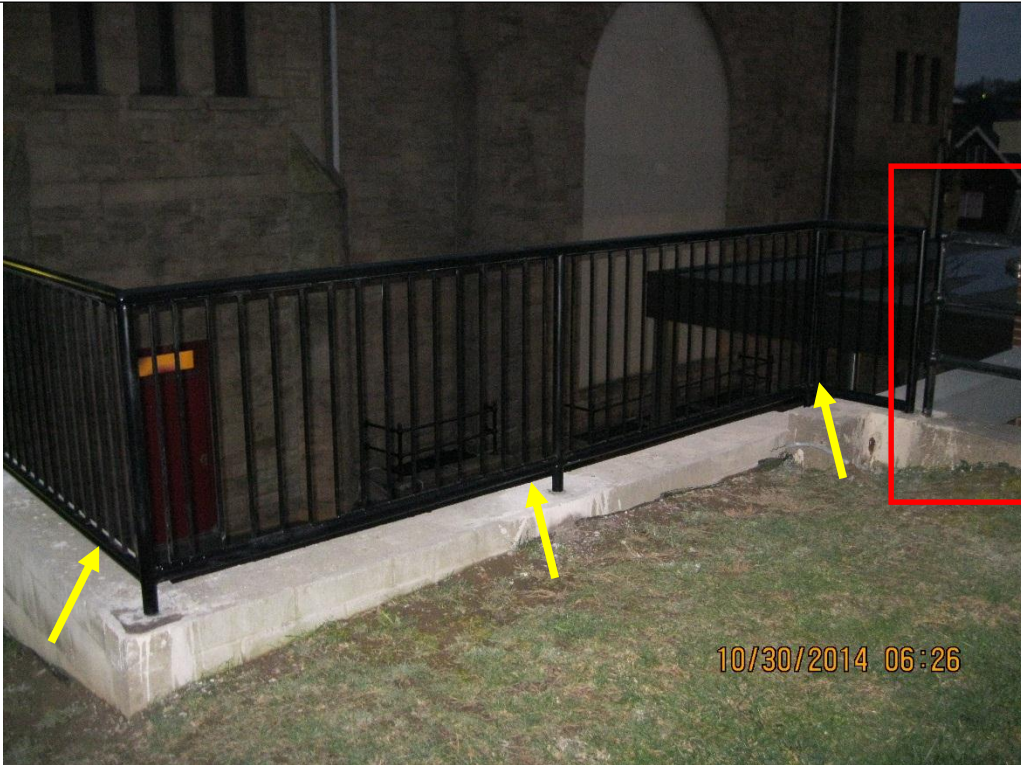
## Alley way behind Wise Library and White Hall

No railing was previously present. A 12' fall hazard to the lower road was present. A matching hand rail set to industry standards of 42" was constructed and installed. The old three post rail can be seen in the upper right (red). The new hand rail (yellow).

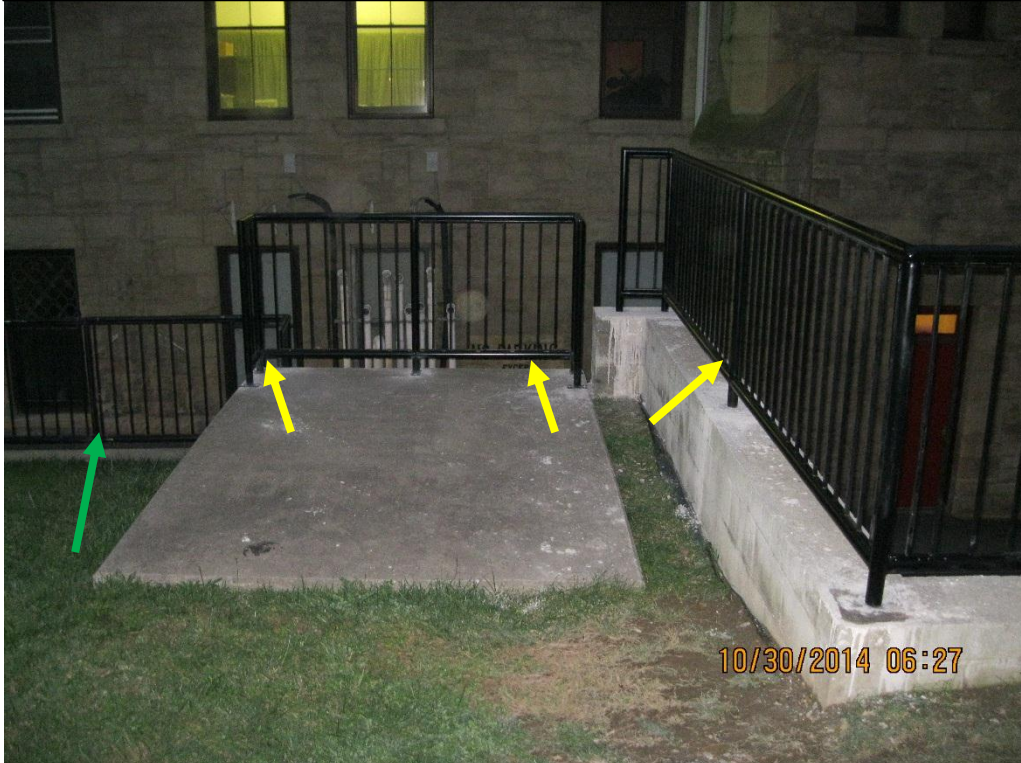
Existing hand rail that was matched (green). Other section of new hand rail installed (yellow).
